AICA NZ – H-101 DOWTHERM CONDENSER REPAIR PROJECT

AICA RESIN PLANT, RICHMOND, NELSON, NEW ZEALAND

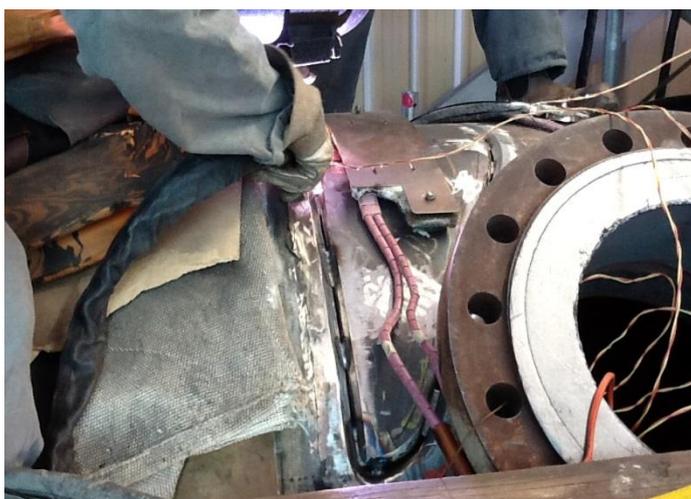
Shell Patch Tacked and Pre-Heated – Welding Commenced

The project was originally considered as a straightforward weld repair - excavating and burr grinding to remove cracks, followed by re-welding. The excavation of the cracks proved difficult and the cracking was extensive. It was proposed that the affected shell section be removed and a new patch installed. On the same day as the decision was made, the patch had been cut, rolled and dispatched for next day delivery.

Fitzroy mobilised a team of welders, led by an experienced QC Welding Inspector. A team of Heat Treatment Technicians were also mobilised to provide controlled pre-heating for welding. Due to the high importance, the project was operated on a 24 hour basis. As the tubesheet cracks were removed and inspected, then the tubesheet was built-up and dressed to create the correct weld preparation profile.

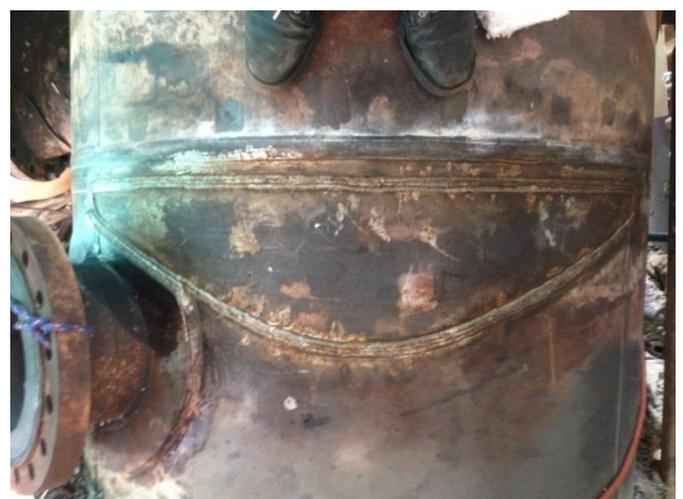
The Completed Shell Patch Installation

The SGS Statutory Inspector was present for the project and was regularly consulted on the repair strategy. When the patch was fully welded and all temporary attachments removed, then the repaired section was wrapped in insulating material and left to cool slowly. When at ambient the vessel was subjected to a hydrostatic test, and after a 24 hour stand down (for possible hydrogen cracking), NDT was repeated, followed by Handover.
